28 February 2012

Respiratory Users Bulletin Regarding DC5040X Series Dual Cool Tube

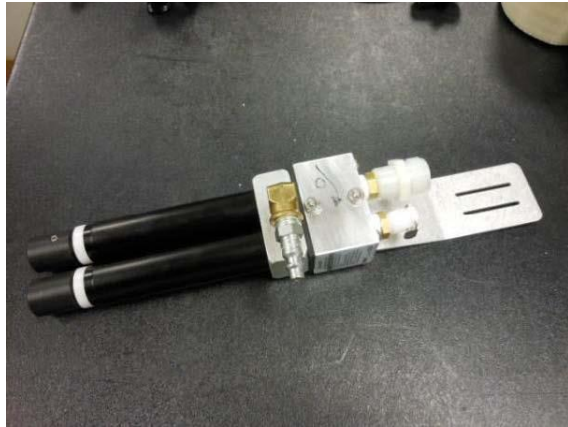
Picture 1

During a recent evaluation at NIOSH, it was discovered that the DC5040 Dual Cool Tube has the potential to leak air in the vicinity of the Exhaust Tubes of the device. Further evaluation determined that supplied air was bypassing the exhaust tube gasket due to insufficient compression of the gasket. Further evaluation by Bullard determined that (leakage notwithstanding) the unit still provided greater than 1000 APF at the minimum flow rate.

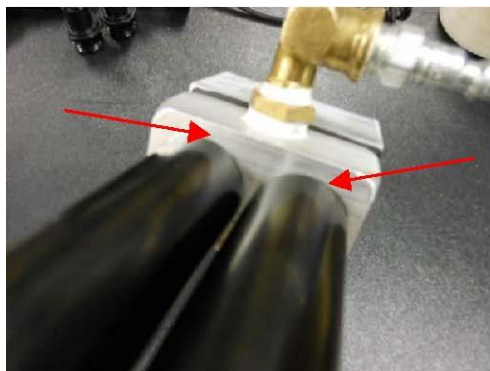
Picture 2

Customers with any model of DC504X series Dual Cool Tube can easily check the unit for air leakage. This can be accomplished by feeling for any air leakage around the black exhaust tube covers where they join the aluminum base of the unit. See picture 2. A better way of detecting it is to apply a bit of soapy water (see picture 3) to the junction and observe whether any bubbles begin to form, indicating leakage.

Feel for leakage here

If leakage is discovered, the user should contact Bullard Customer Service at 877 285-5273 and reference this bulletin. A Return Authorization will be provided to return the unit to Bullard for repair /replacement.

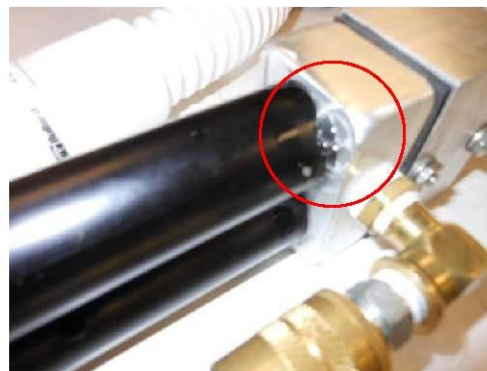
Picture 3

Example of soapy water test for leakage
